HYDRAULIC MODEL STUDIES
OF WILLOW CREEK DAM AUXILIARY SPILLWAY

Hydraulic Laboratory Report No. Hyd-356

Hydraulic model studies of the Willow Creek Dam auxiliary spillway, a part of the Colorado-Big Thompson Project, were conducted in the laboratory of the Bureau of Reclamation at Denver, Colorado, during the period of August 1950 to May 1951.

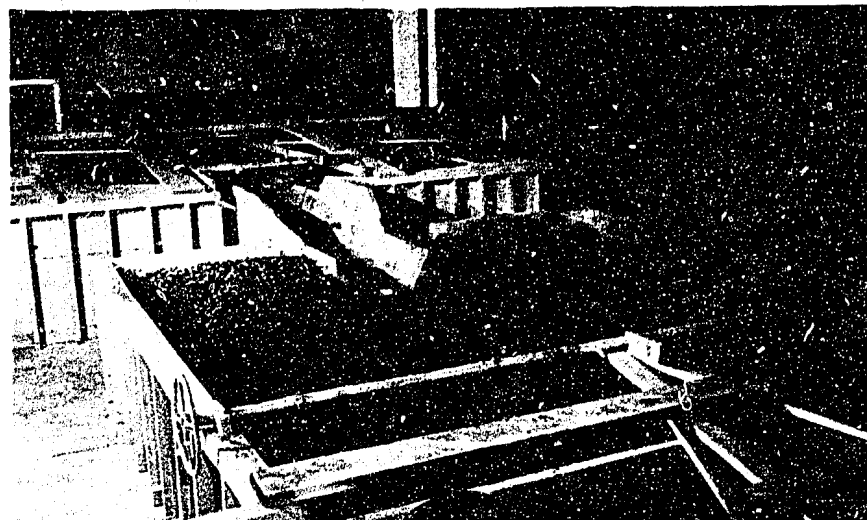
Model layout

U-shaped double side channel spillway

WILLOW CREEK DAM AUXILIARY SPILLWAY
Model Views--Preliminary Design
1:15 Scale Model

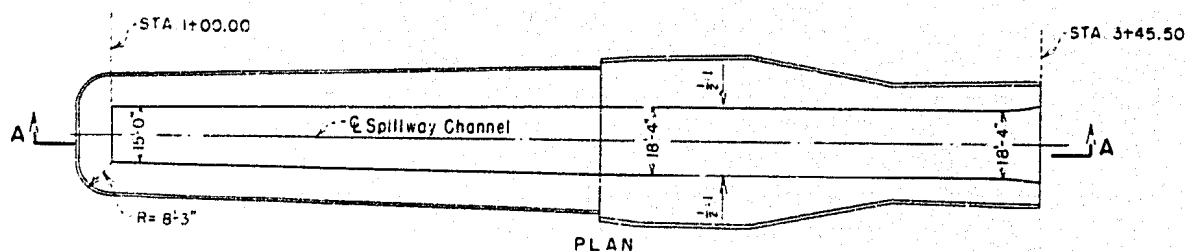
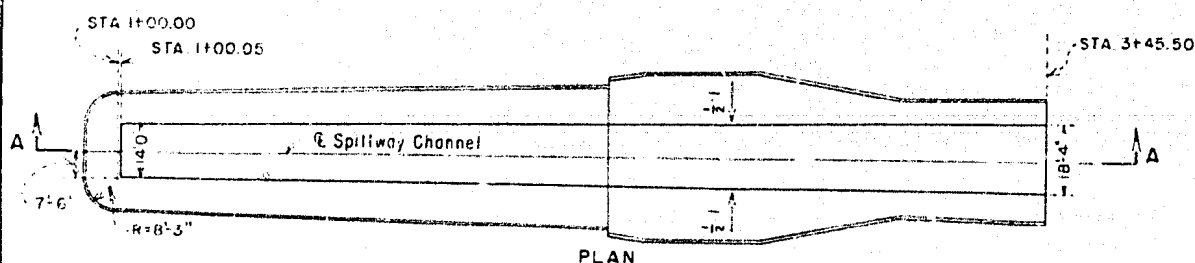
SECTION A-A
PRELIMINARY DESIGN

SECTION A-A
DESIGN No. 2

Note All three Designs are identical except for chute floor modifications.

SECTION A-A
DESIGN No. 3

WILLOW CREEK DAM AUXILIARY SPILLWAY
SPILLWAY CHUTE DESIGNS TESTED
1:15 SCALE MODEL

Description. The preliminary design is shown in Figure 7. The U-shaped crest was approximately 300 feet long measured along the crest axis. The over-all length of the chute was 245.50 feet measured horizontally from Station 1+00. The over-all width of the structure varied from 38 feet 1-3/4 inches wide at Station 2+30, the downstream end of the U-shaped crest, to 31 feet 6 inches wide at Station 1+00, the upstream end. The chute floor was 15 feet wide from Station 1+00 to Station 2+40 and sloped downstream at the rate of 0.05 foot per foot of horizontal length. A crestlike step or rise in the floor at Station 2+40 was 3 feet 4 inches high. The chute floor width was 18 feet 4 inches wide downstream from the step and sloped downstream to the deflector at the rate of 0.0362-foot drop in 1 foot of horizontal length. The deflector at the end of the chute was a vertical curve in the chute floor that rose 3 feet in a horizontal distance of 9 feet 6 inches.

Description. In spillway Chute Design No. 2 only the chute floor was changed as shown in Figure 7. The step in the preliminary design was eliminated by raising the floor upstream from the step to the same slope as the floor downstream. The elevation of the floor at the upstream end and the downstream end was the same as in the preliminary design.

Description. Chute Design No. 3 is shown in Figure 7. The upstream end of the sloping chute floor was lowered 1 foot below that of the two previous designs. The elevation of the downstream end of the chute remained unchanged.

Description. The recommended design utilized the upstream portion of Chute Design No. 3 shown in Figure 7 but was extended approximately 100 feet farther downstream as shown in Figures 2 and 3. At the end of the longer chute a deflector was installed to direct the flow upward and away from the channel bed.

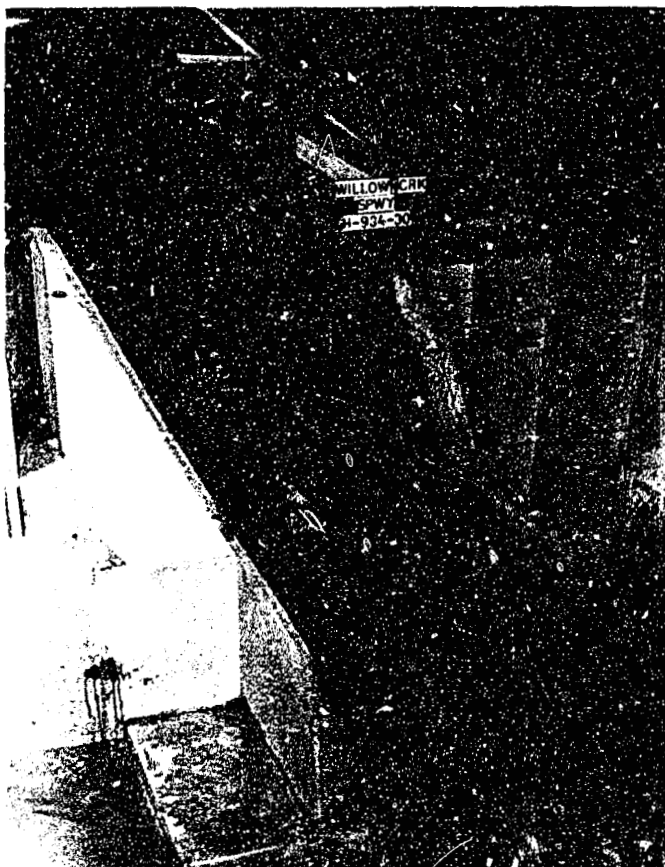
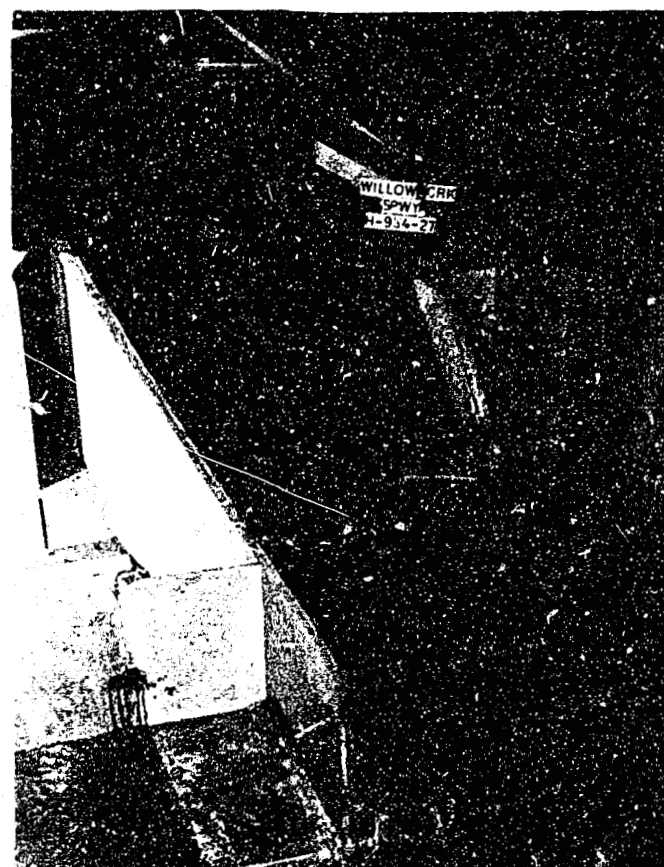
Design discharge 3, 100 second-feet

5, 200 second-feet

WILLOW CREEK DAM AUXILIARY SPILLWAY
Preliminary Design--Flow Through The Structure
1:15 Scale Model

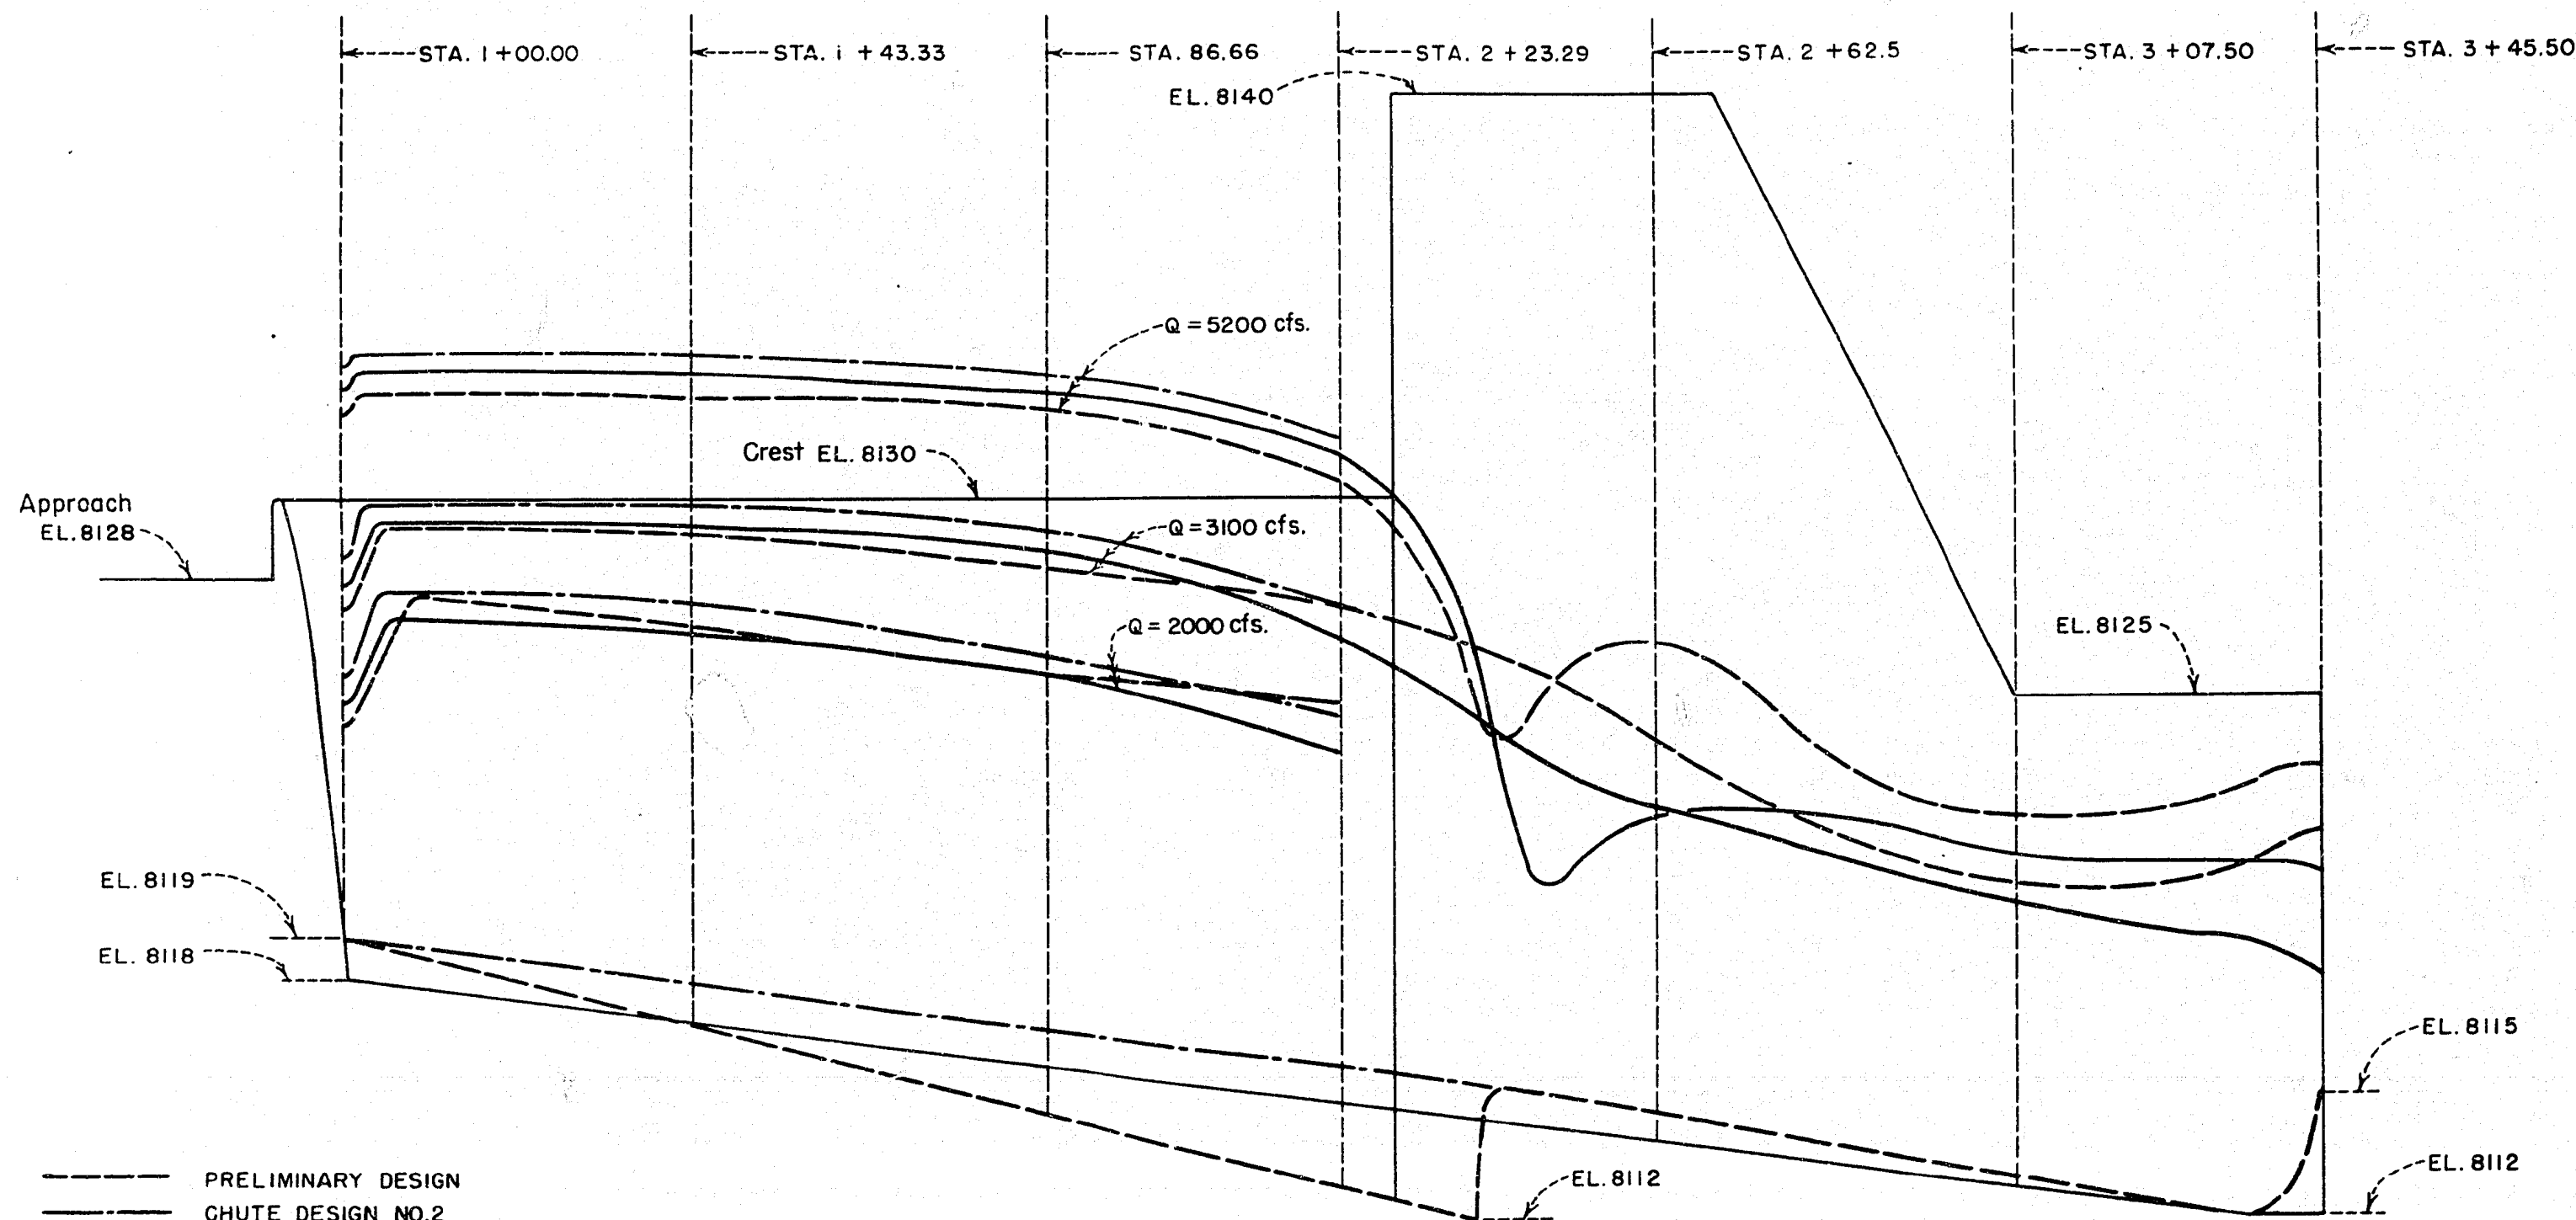
----- PRELIMINARY DESIGN
 _____ CHUTE DESIGN NO. 2
 _____ CHUTE DESIGN NO. 3

Note: Recommended design profiles upstream from STA. 2+62.5 are identical to those for design NO. 3., those downstream are shown in Figure 21

WILLOW CREEK DAM AUXILIARY SPILLWAY
 WATER-SURFACE PROFILES ON $\frac{1}{2}$ OF SPILLWAY
 1:15 SCALE MODEL

Vertical Scale 1" = 4'
 Horizontal Scale 1" = 20'

Flow characteristics, calibration, and erosion. The recommended design is shown operating in Figures 19 and 20. Flow in the double-side channel portion of the chute was not changed from that in Design No. 3 shown in Figure 15. Therefore, water surface profiles in that portion of the chute, Figures 10 and 11, and the discharge calibration, Figure 12, were the same for the recommended design as for Design No. 3.

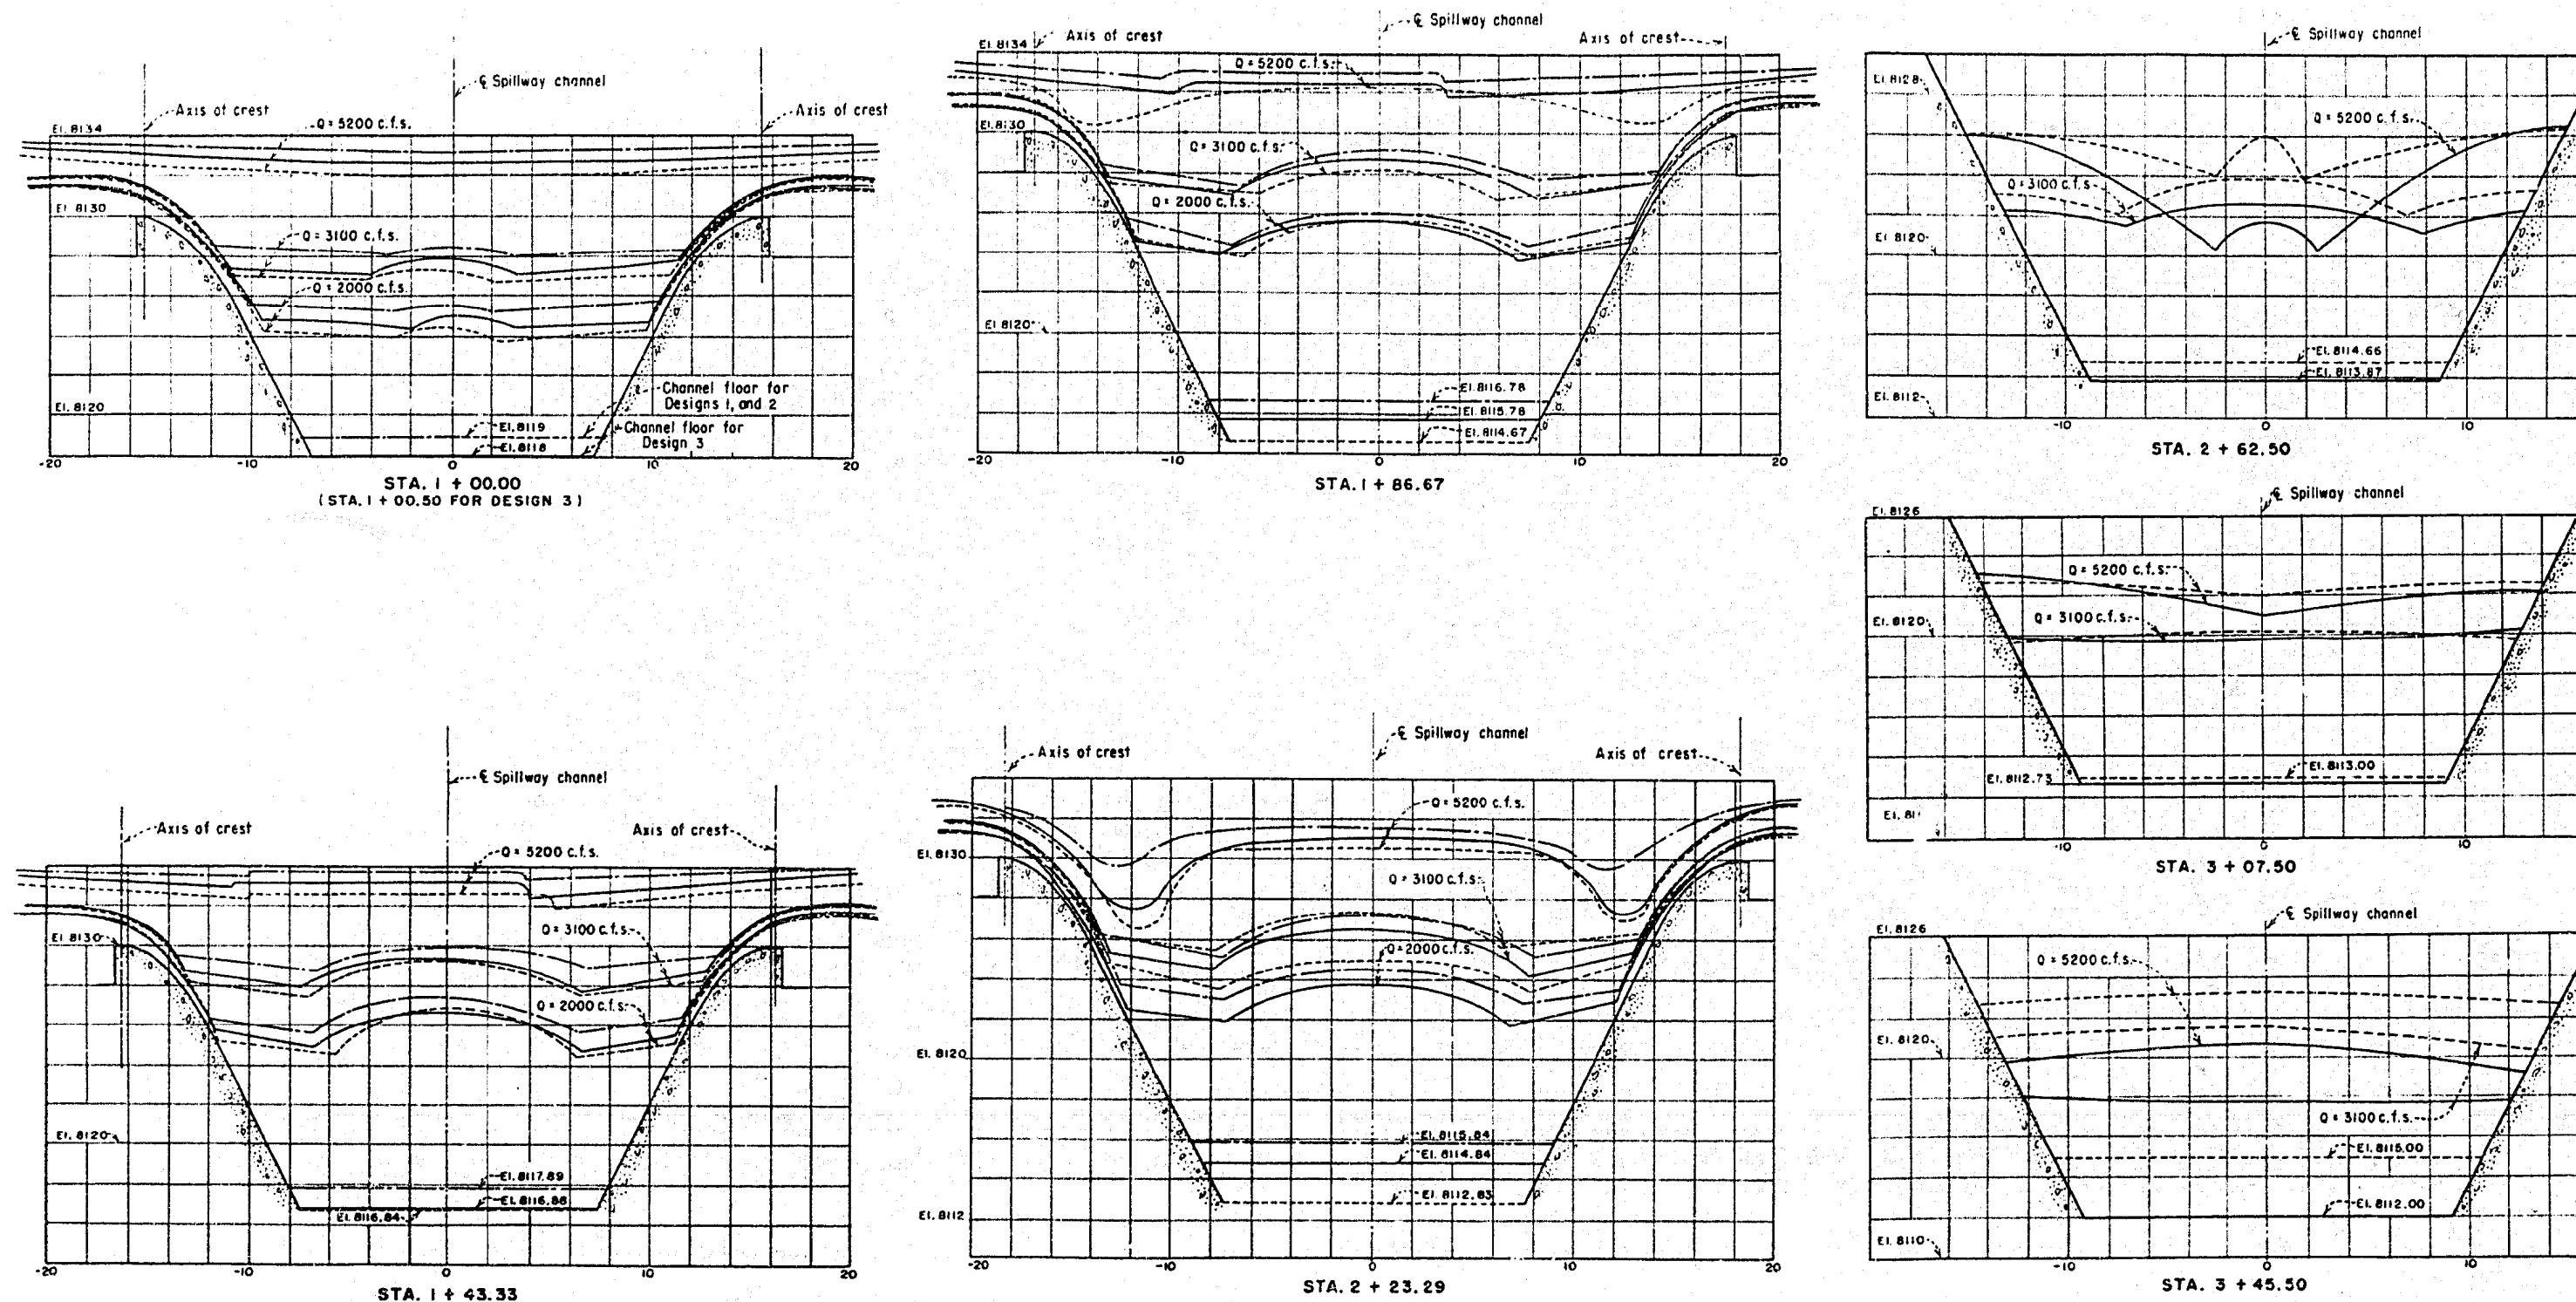
NOTES
Recommended design profiles at stations upstream from 2 + 62.5 are identical to those for design No. 3, those at stations downstream are shown in figure 22.
All sections are taken looking downstream.

**WILLOW CREEK DAM AUXILIARY SPILLWAY
SECTIONAL WATER SURFACE PROFILES**
1:15 SCALE MODEL

SYMBOLS
Preliminary design -----
Chute design No. 2 -----
Chute design No. 3 -----

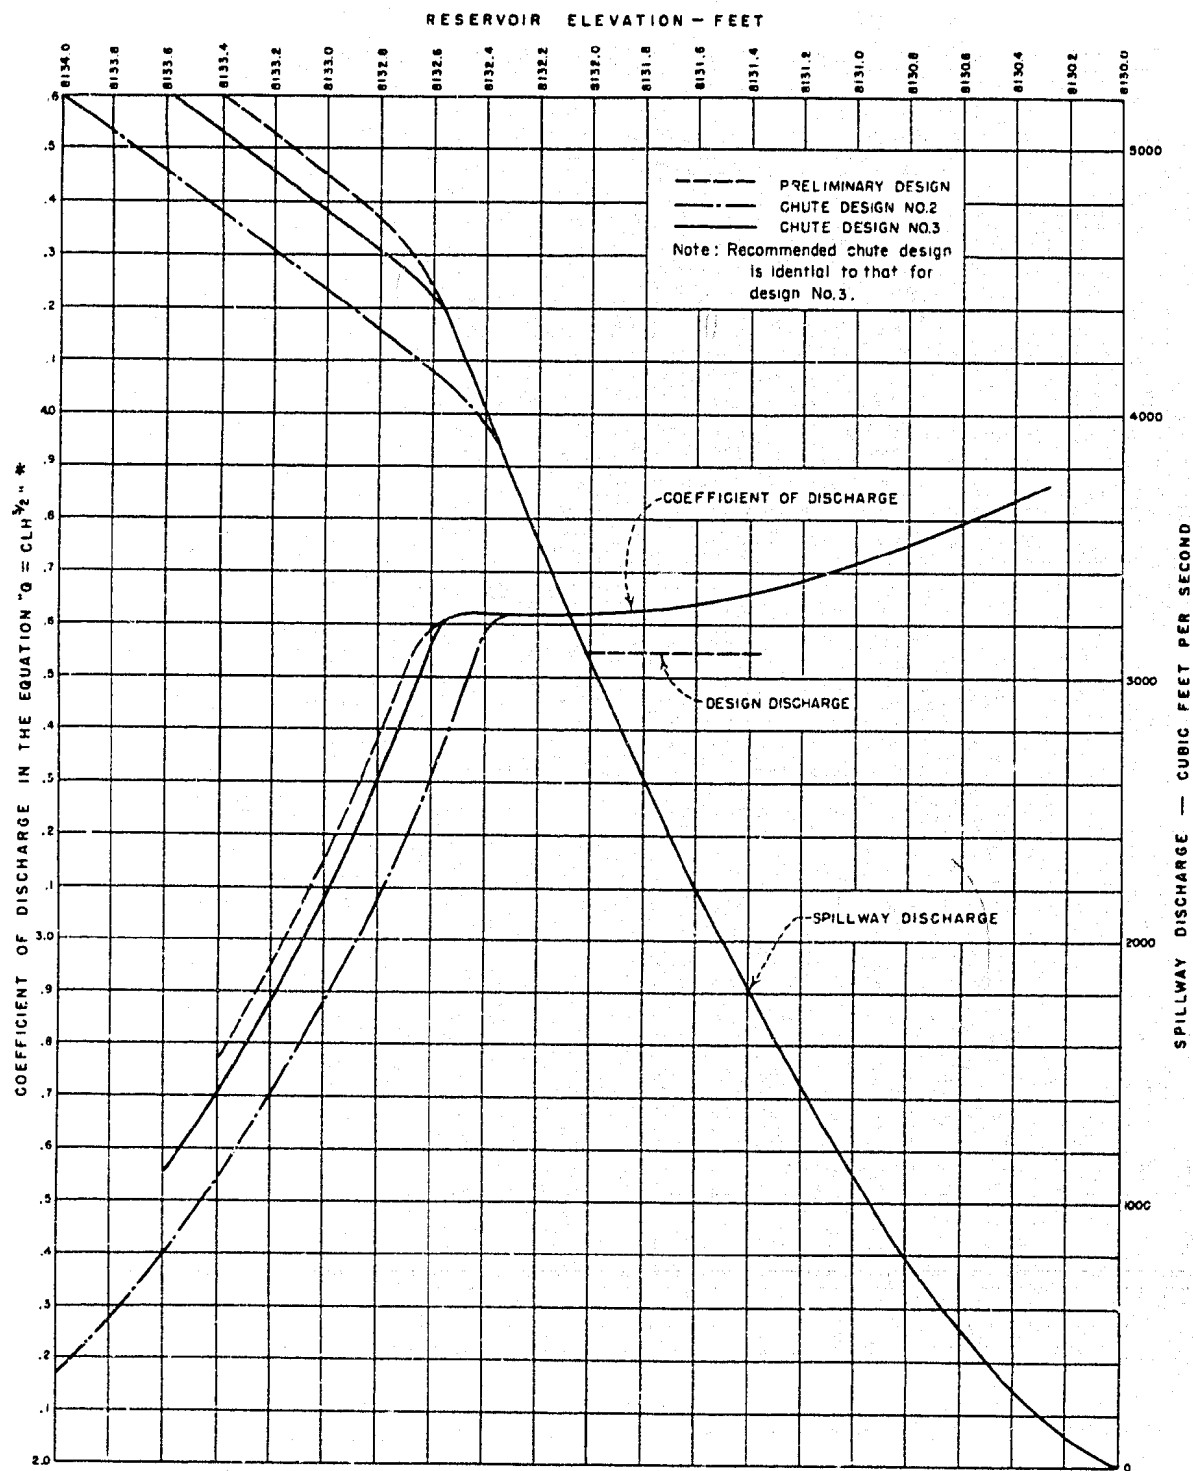
FIGURE 12
REPORT HYD. 356

* Note: Length of Spillway Crest "L" is measured along the crest axis at El. 8130.

WILLOW CREEK DAM AUXILIARY SPILLWAY
SPILLWAY DISCHARGE AND COEFFICIENT OF DISCHARGE CURVES
1:15 SCALE MODEL

Calibration. Calibration of the spillway crest disclosed the capacity of the spillway for the design reservoir elevation to be 3,050 second feet as shown by the discharge curve in Figure 12 which is very close to the anticipated flow of 3,100 second feet. The efficiency of the crest was indicated by the coefficient of discharge "C" in the discharge equation:

The coefficient of discharge is plotted against reservoir elevation in Figure 12 and indicates an efficient design. For the design reservoir elevation the coefficient is about 3.62 and even larger for lower reservoirs.

Calibration. Discharge and coefficient of discharge curves obtained from the calibration data are shown in Figure 12. Up to approximately 4,300 second feet the curves are identical to those for the preliminary design. At approximately 4,300 second feet, the crest was submerged which is a slightly lower discharge than for the preliminary design. At the maximum discharge approximately 0.2 foot higher reservoir elevation was required to discharge the flow. However, approximately 0.4 foot less head was required than for Design No. 2. This alignment of the chute floor was, therefore, considered to be adequate by the designers.

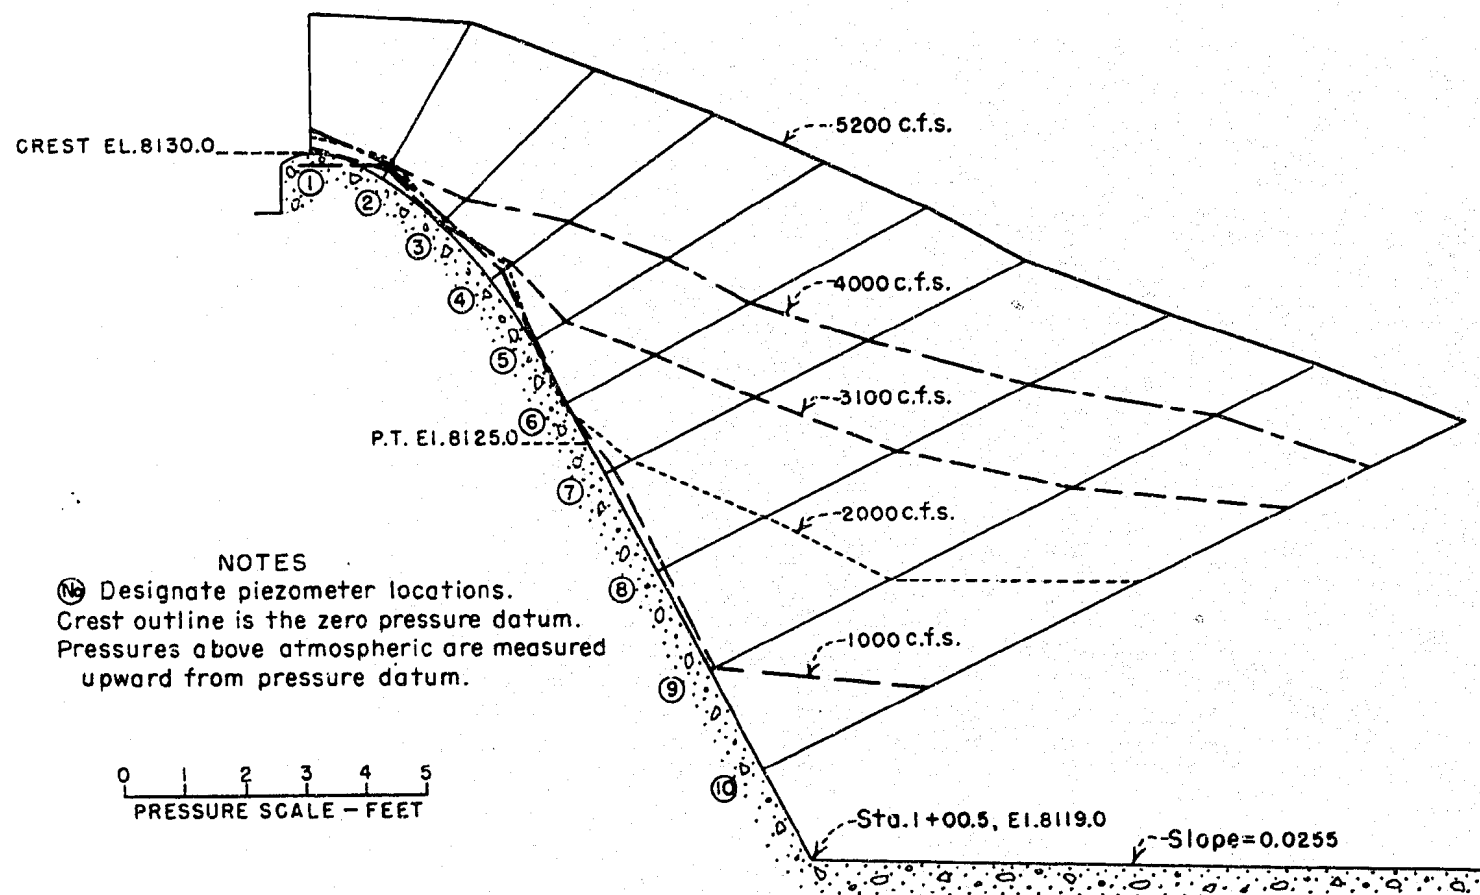
WILLOW CREEK DAM AUXILIARY SPILLWAY

CREST PRESSURES

1:15 MODEL

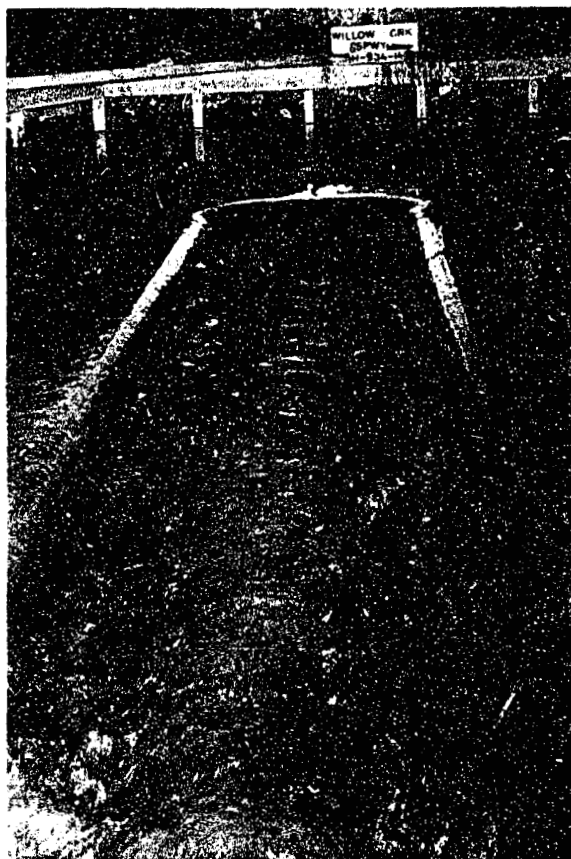
Design discharge 3,100 second-feet

4,000 second-feet

5,200 second-feet

WILLOW CREEK DAM AUXILIARY SPILLWAY
Flow Through Double Side Channel Chute of Design No. 2
1:15 Scale Model

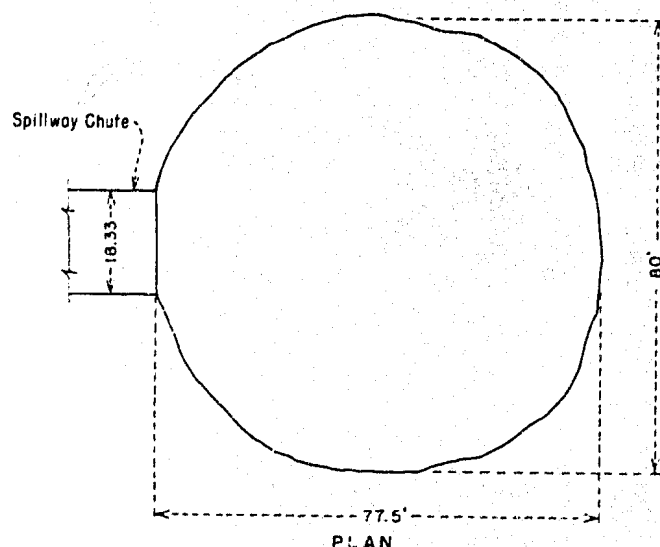
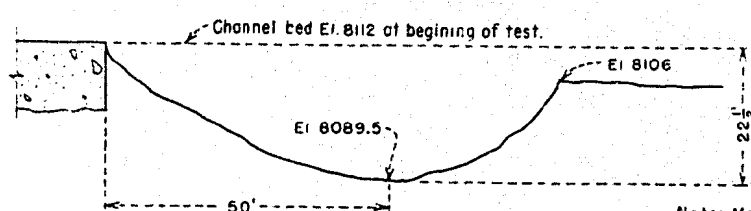
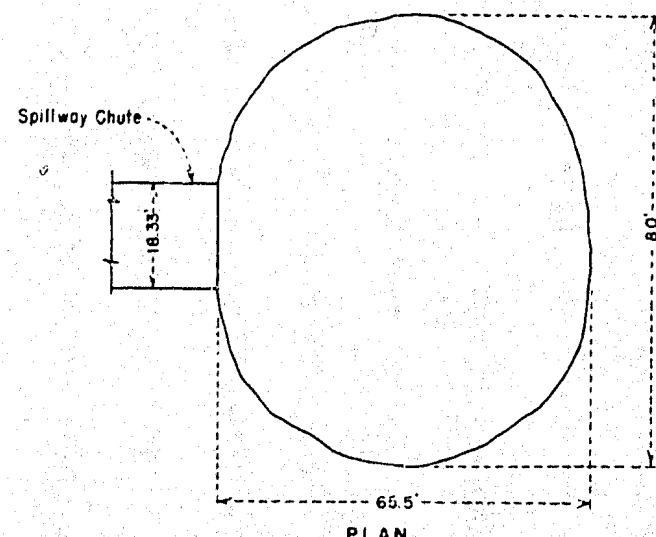
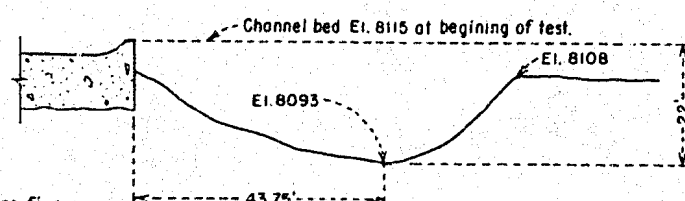
Note: Model erosion tests were five minutes long with the design discharge, Figures 16 and 18.

WILLOW CREEK DAM AUXILIARY SPILLWAY
EROSION MEASUREMENTS WITH AND WITHOUT DEFLECTOR
1/15 SCALE MODEL

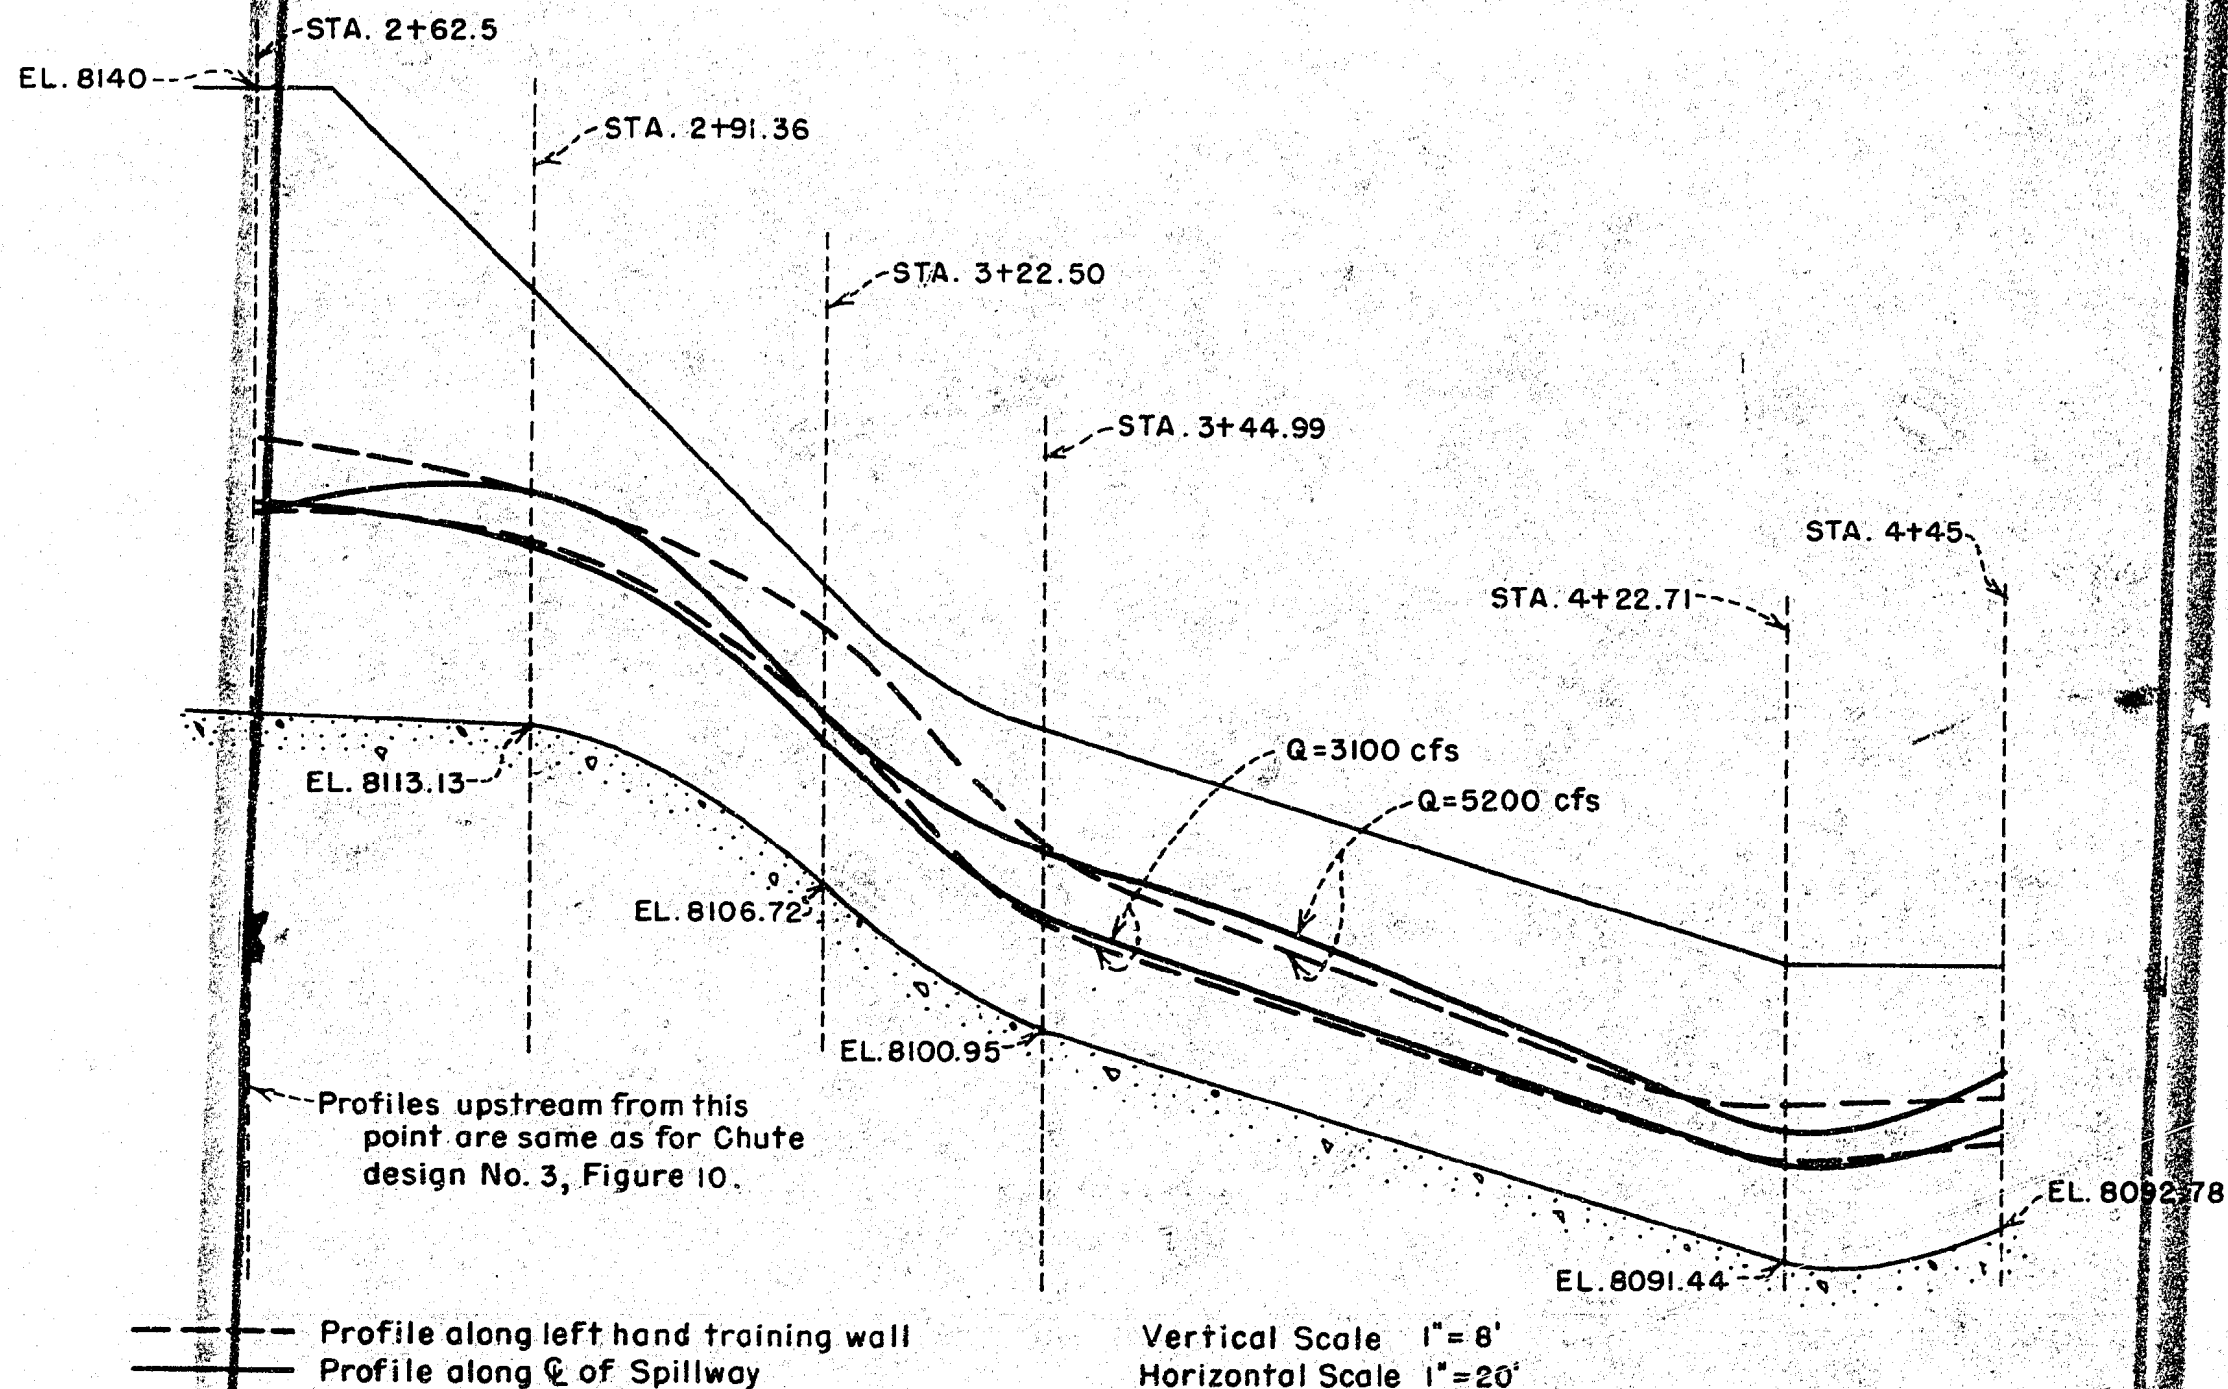
WILLOW CREEK DAM AUXILIARY SPILLWAY
 WATER SURFACE PROFILES
 RECOMMENDED DESIGN
 1:15 SCALE MODEL

Water surface profiles were recorded in the extended portion of the chute along the center line and the left training wall for use in determining training wall heights. Profiles were recorded for discharges of 3,100 and 5,200 second feet, shown in Figure 21. Transverse profiles were recorded at several stations as shown in Figure 22. Erosion at the end of the structure was similar to that for Design No. 3. Spillway Design No. 3 with the longer chute, as shown in Figure 3, is, therefore, recommended for the prototype.

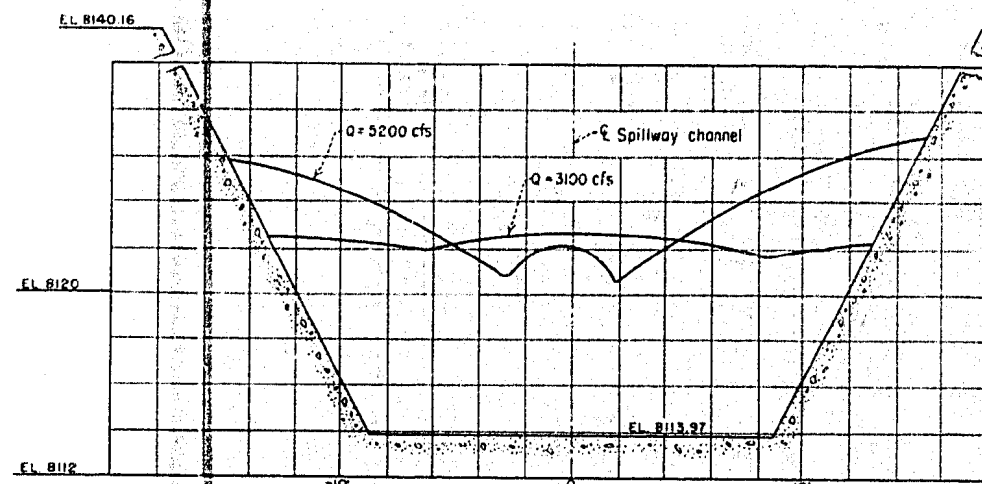
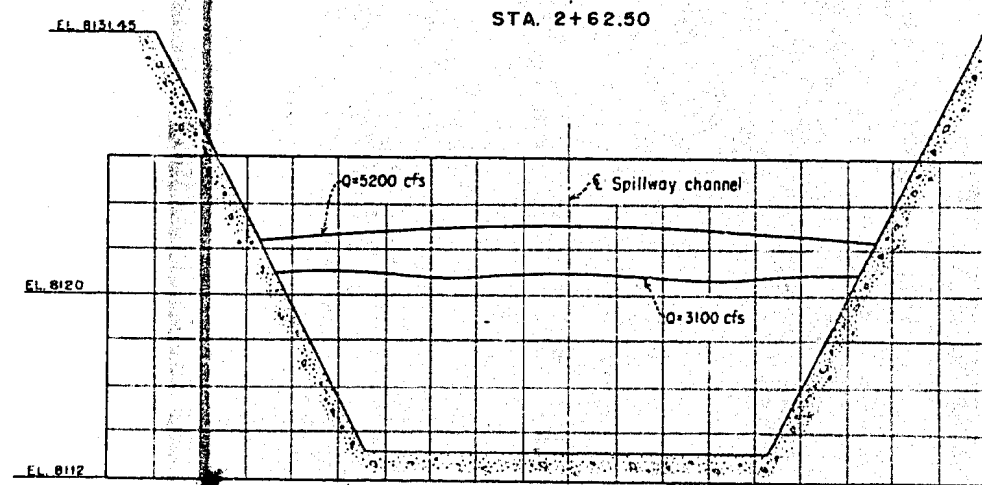
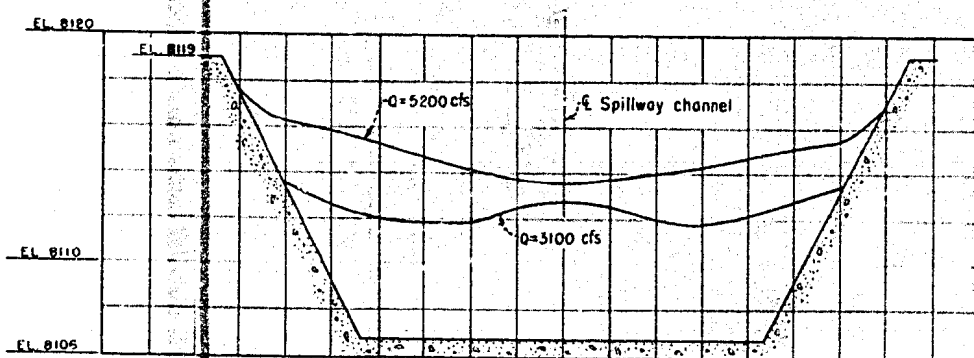
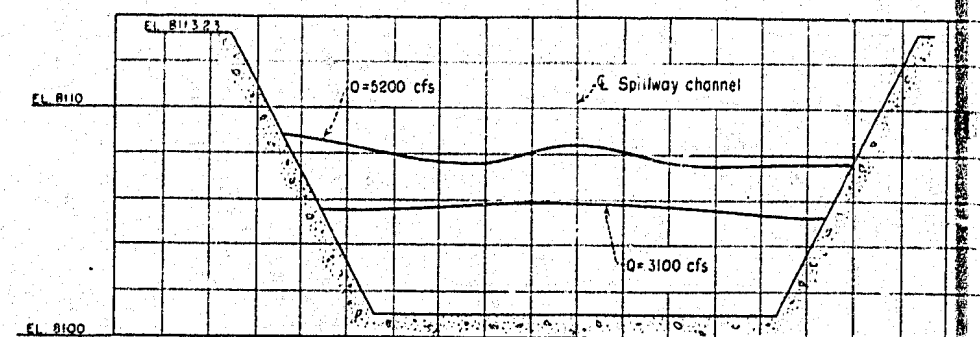
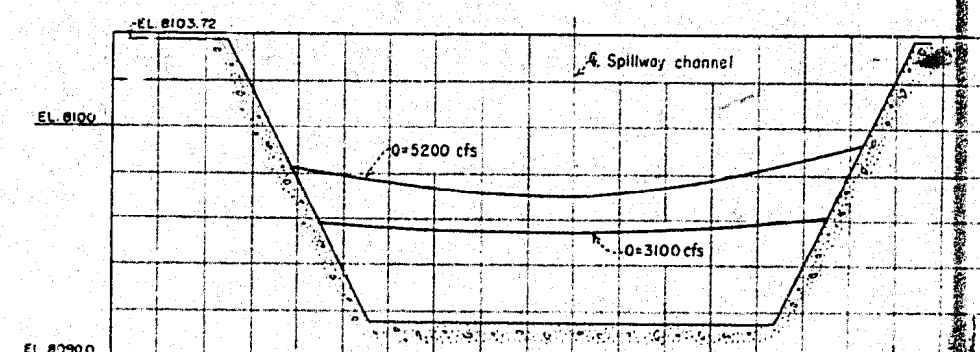
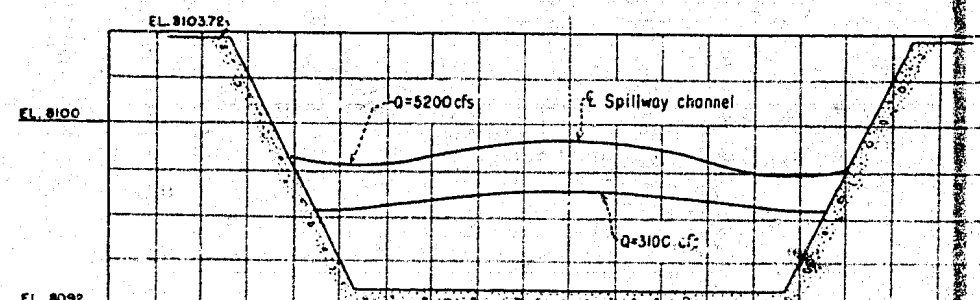
STA. 2+62.50

STA. 2+91.36

STA. 3+22.50

STA. 3+44.99

STA. 4+22.71

STA. 4+45

NOTE
All sections are taken looking downstream.
Sectional profiles upstream from Sta. 2+62.5
are same as for design No. 3, figure 11.

WILLOW CREEK DAM AUXILIARY SPILLWAY
SECTIONAL WATER SURFACE PROFILES
RECOMMENDED SPILLWAY DESIGN
1.15 SCALE MODEL

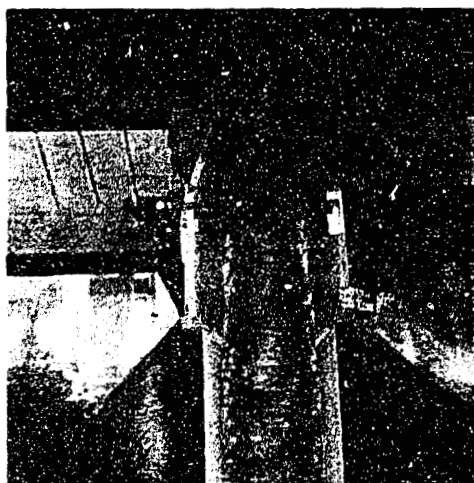
Design discharge - 3,100 second-feet

5,200 second-feet

WILLOW CREEK DAM AUXILIARY SPILLWAY
Flow In The Spillway Approach
1:15 Scale Model

Flow conditions in the spillway approach (Figures 23, 24, and 25) were satisfactory. A minor disturbance at the left inlet wall (Figure 23) was not objectionable.

The spillway approach area is shown in Figure 2. The model investigation disclosed a slight disturbance in the water surface around the left inlet training wall for the design flow of 3,100 second feet and a greater disturbance for the maximum emergency discharge of 5,200 second feet as shown in Figure 23. These disturbances were considered to be minor. Since there was little to be gained by eliminating them, except improved appearance, no changes in the preliminary design were recommended in the approach.
